TECHNICAL INSPECTION REPORT

6 OPERATION CROSSROADS.
U.S.S. CRITTENDEN (APA 77)

TEST ABLE.

VOLUME 2 [U].

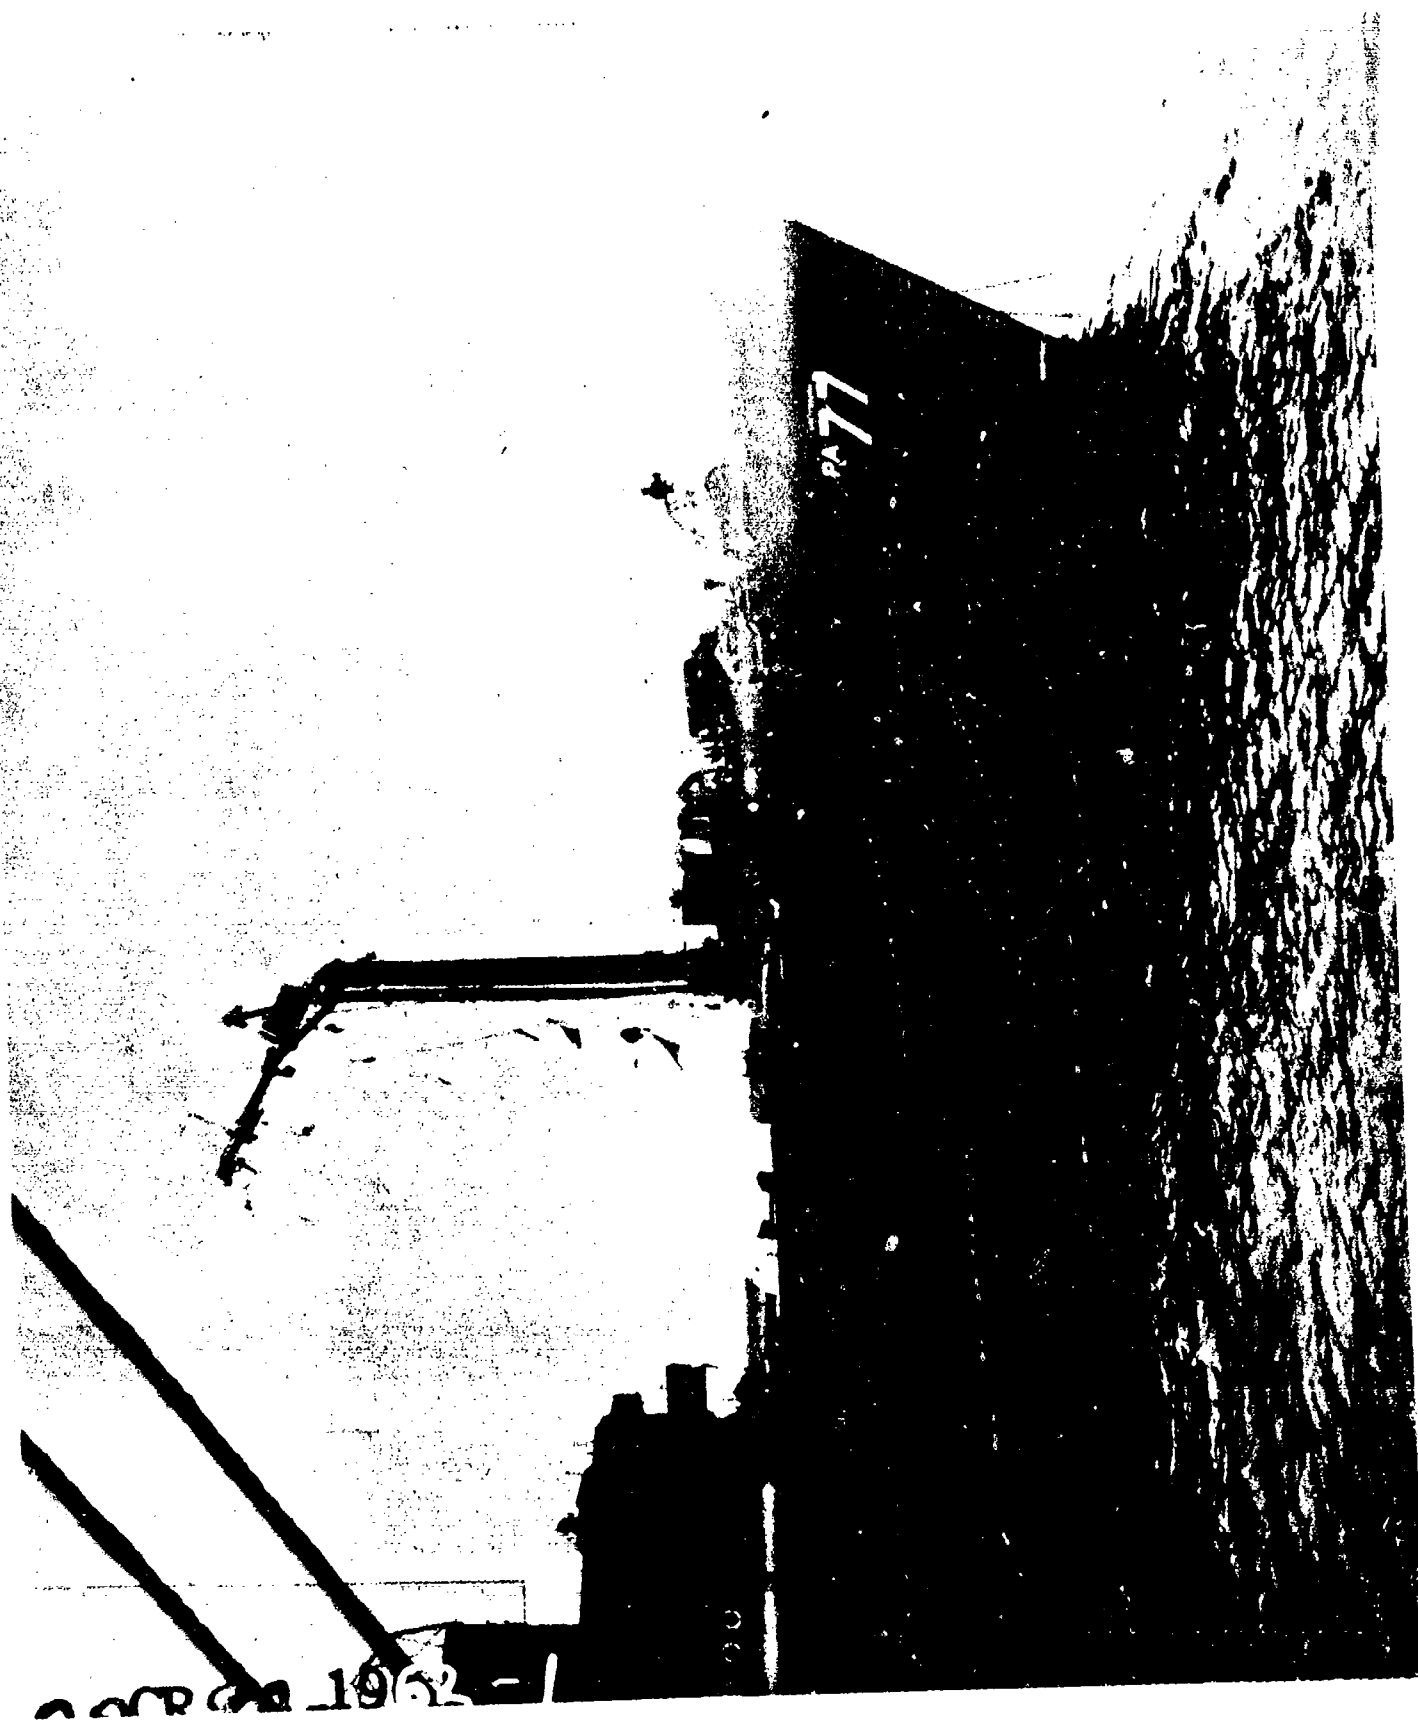
AA-CR-98-1962-1. Starboard side, bow to frame 65.

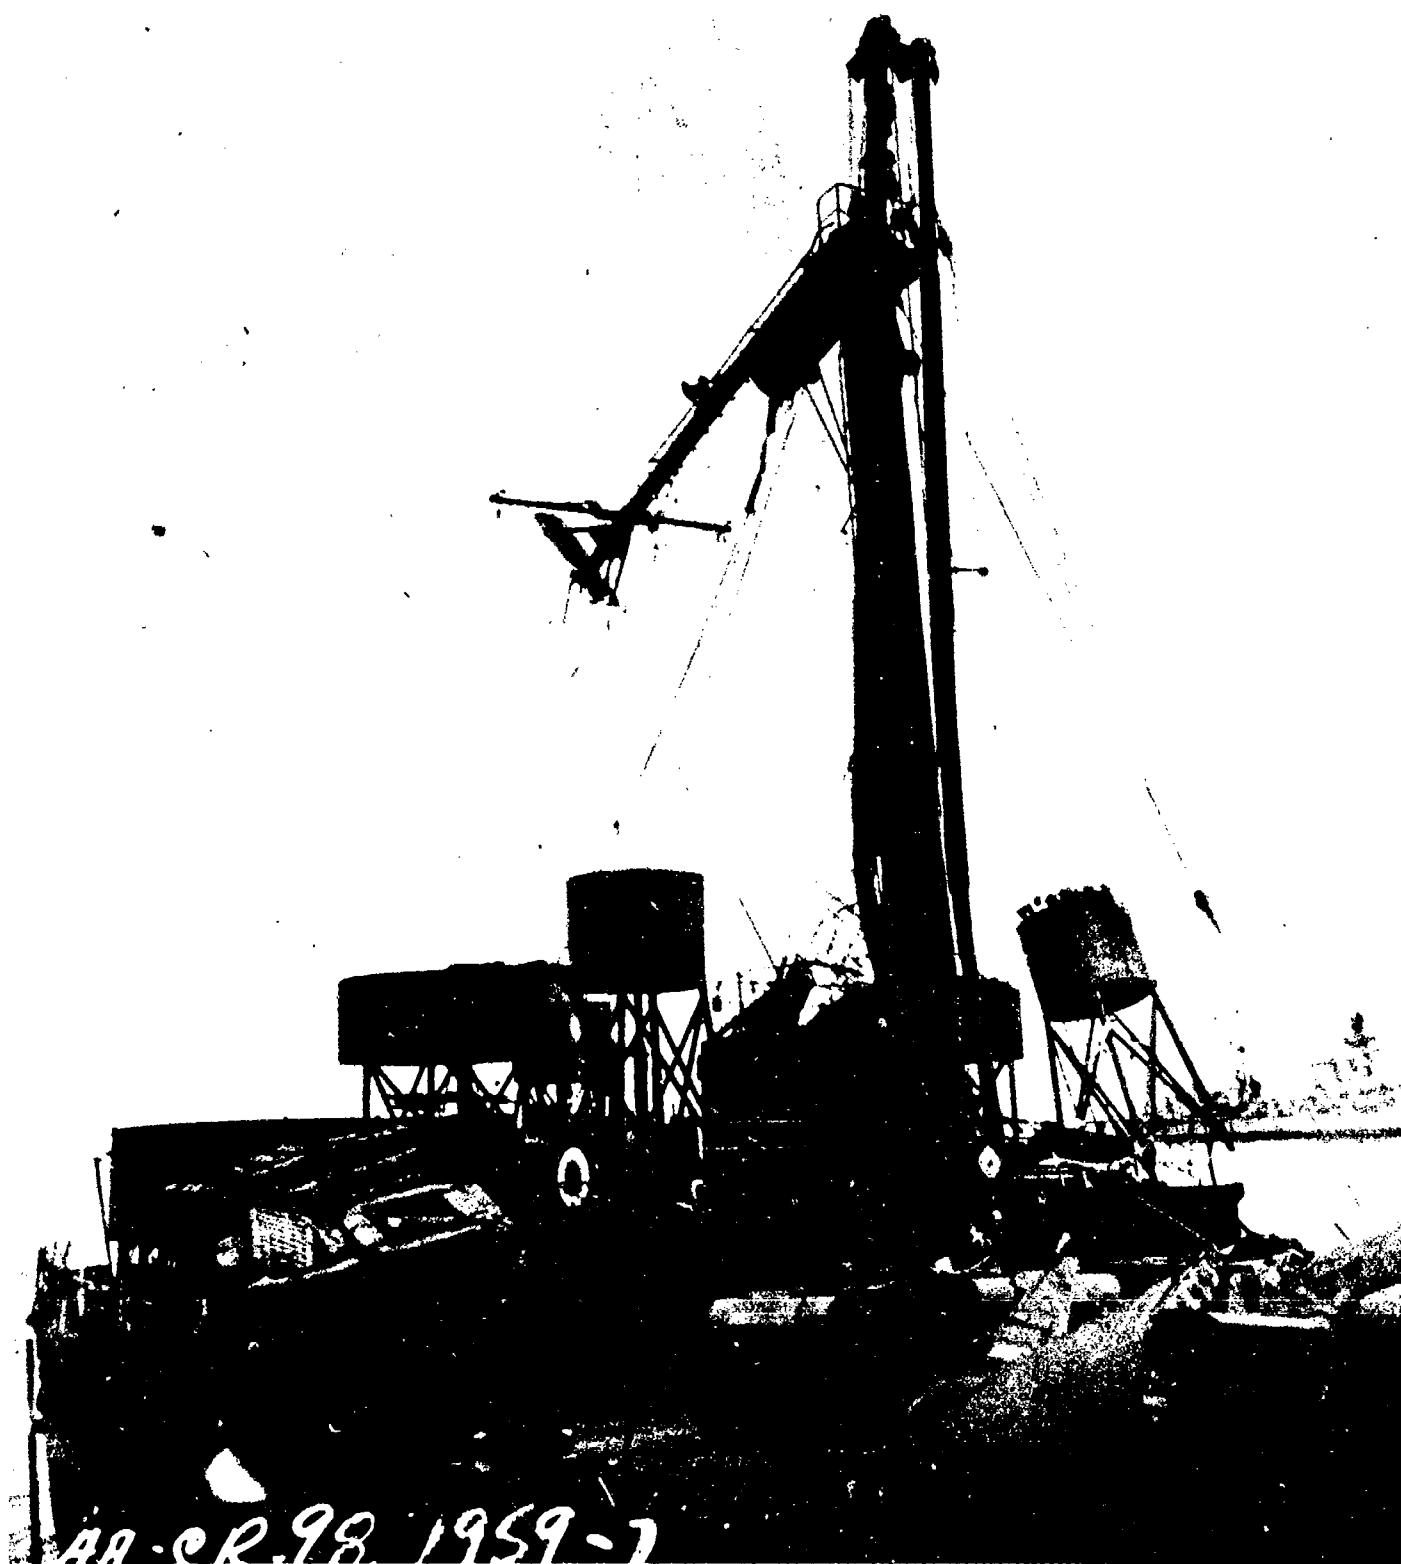
AA-CR-98-1959-7. Looking aft, showing wreckage on mainmast and top of after deck house.

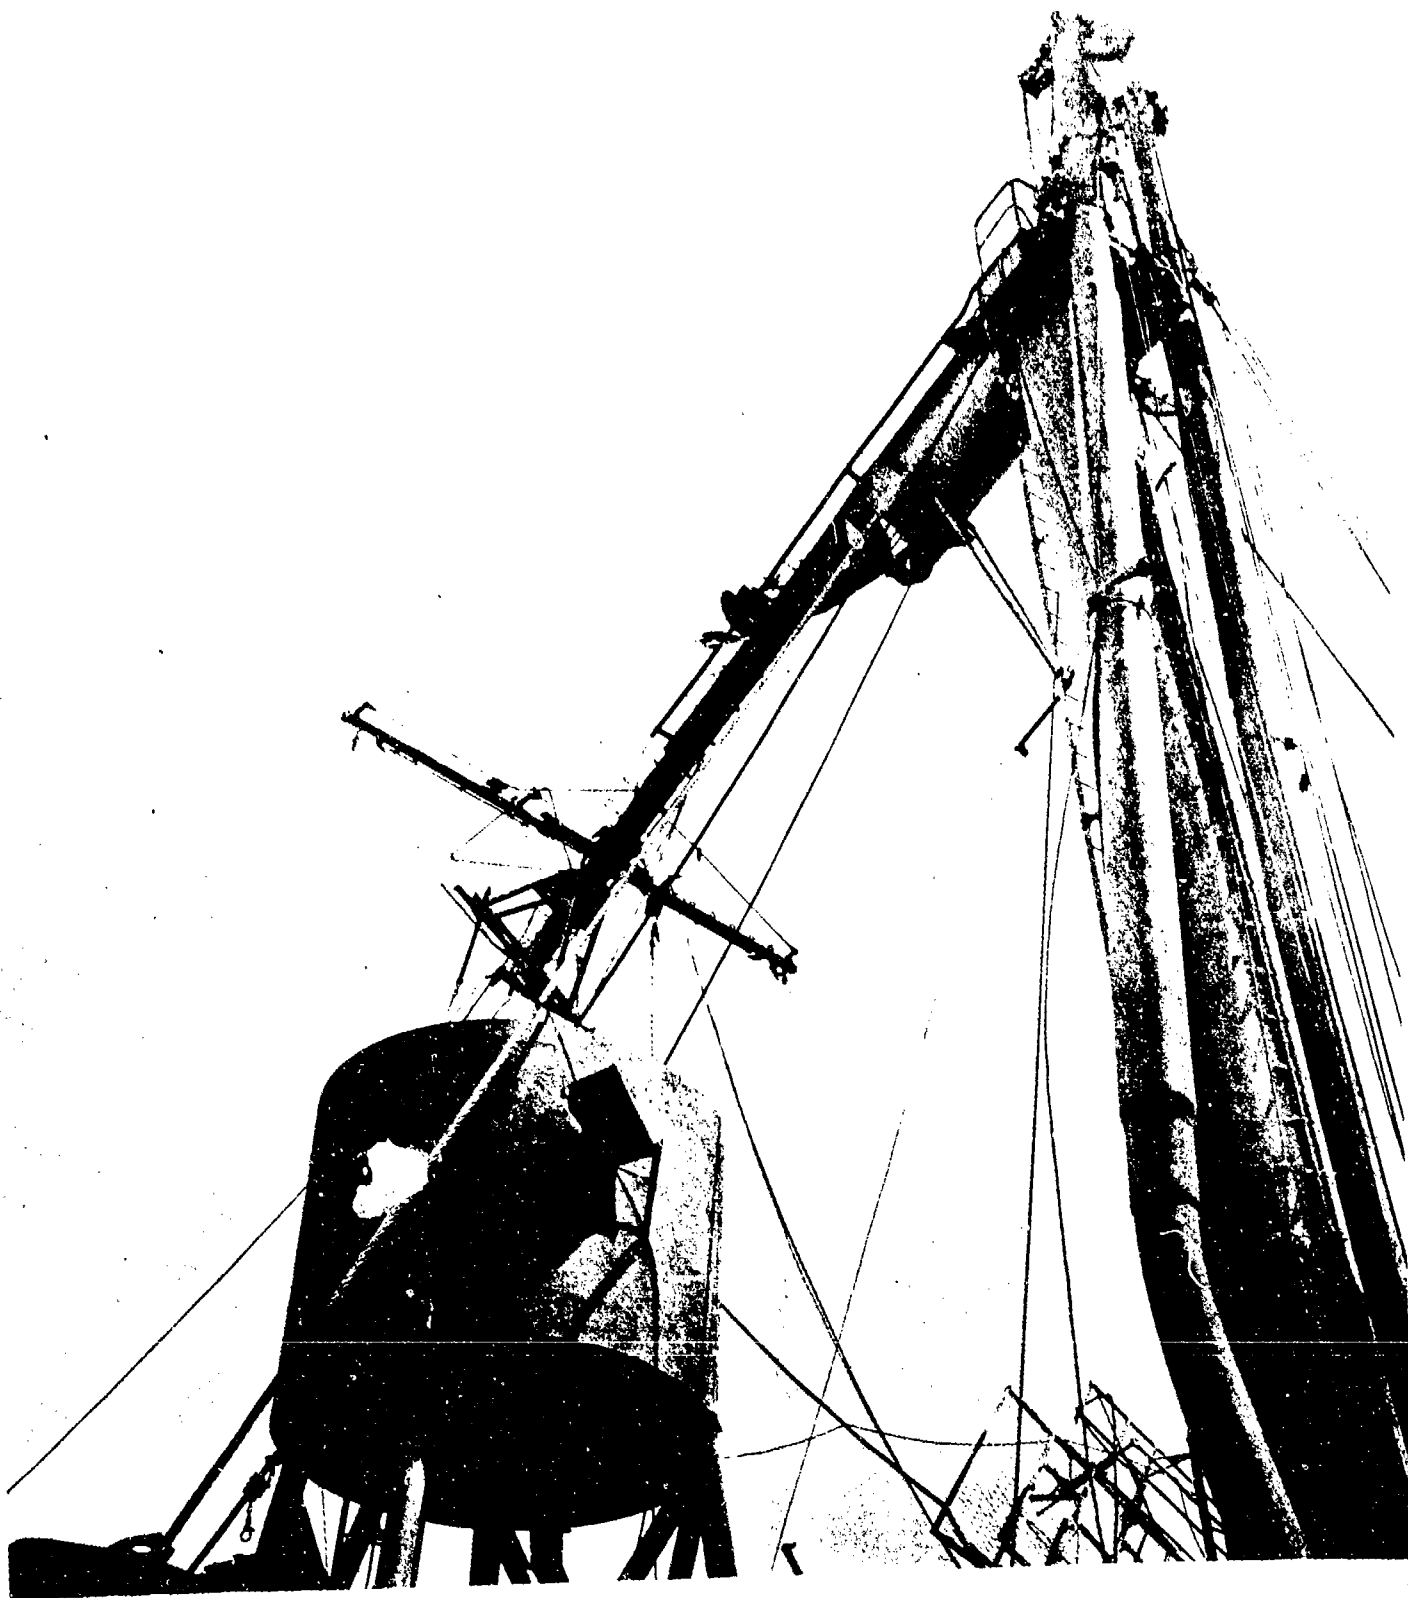
AA-CR-80-1906-9. Looking aft and to port showing bent boom on mainmast and broken main topmast.

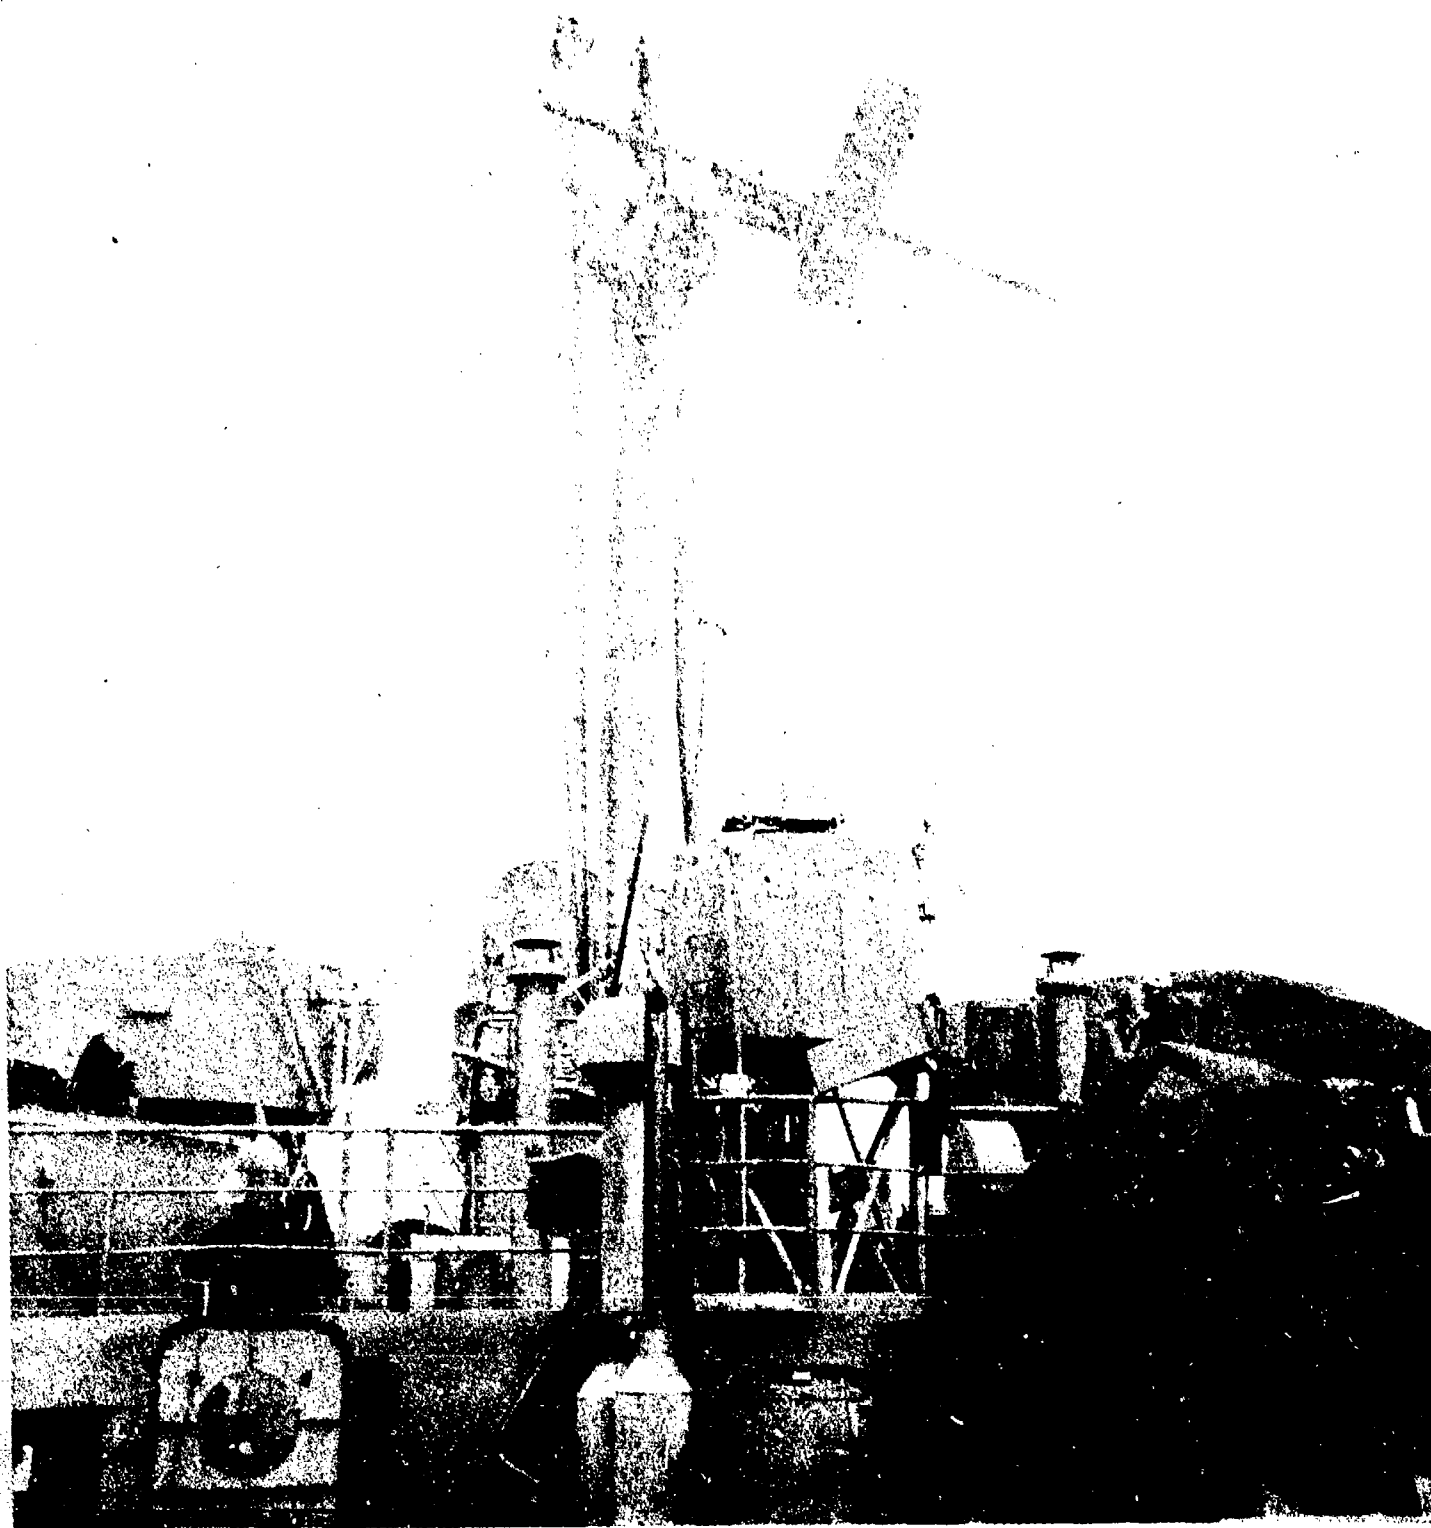
AA-CR-82-1921-12. Looking forward on upper deck from aft of after deck house showing broken main topmast.

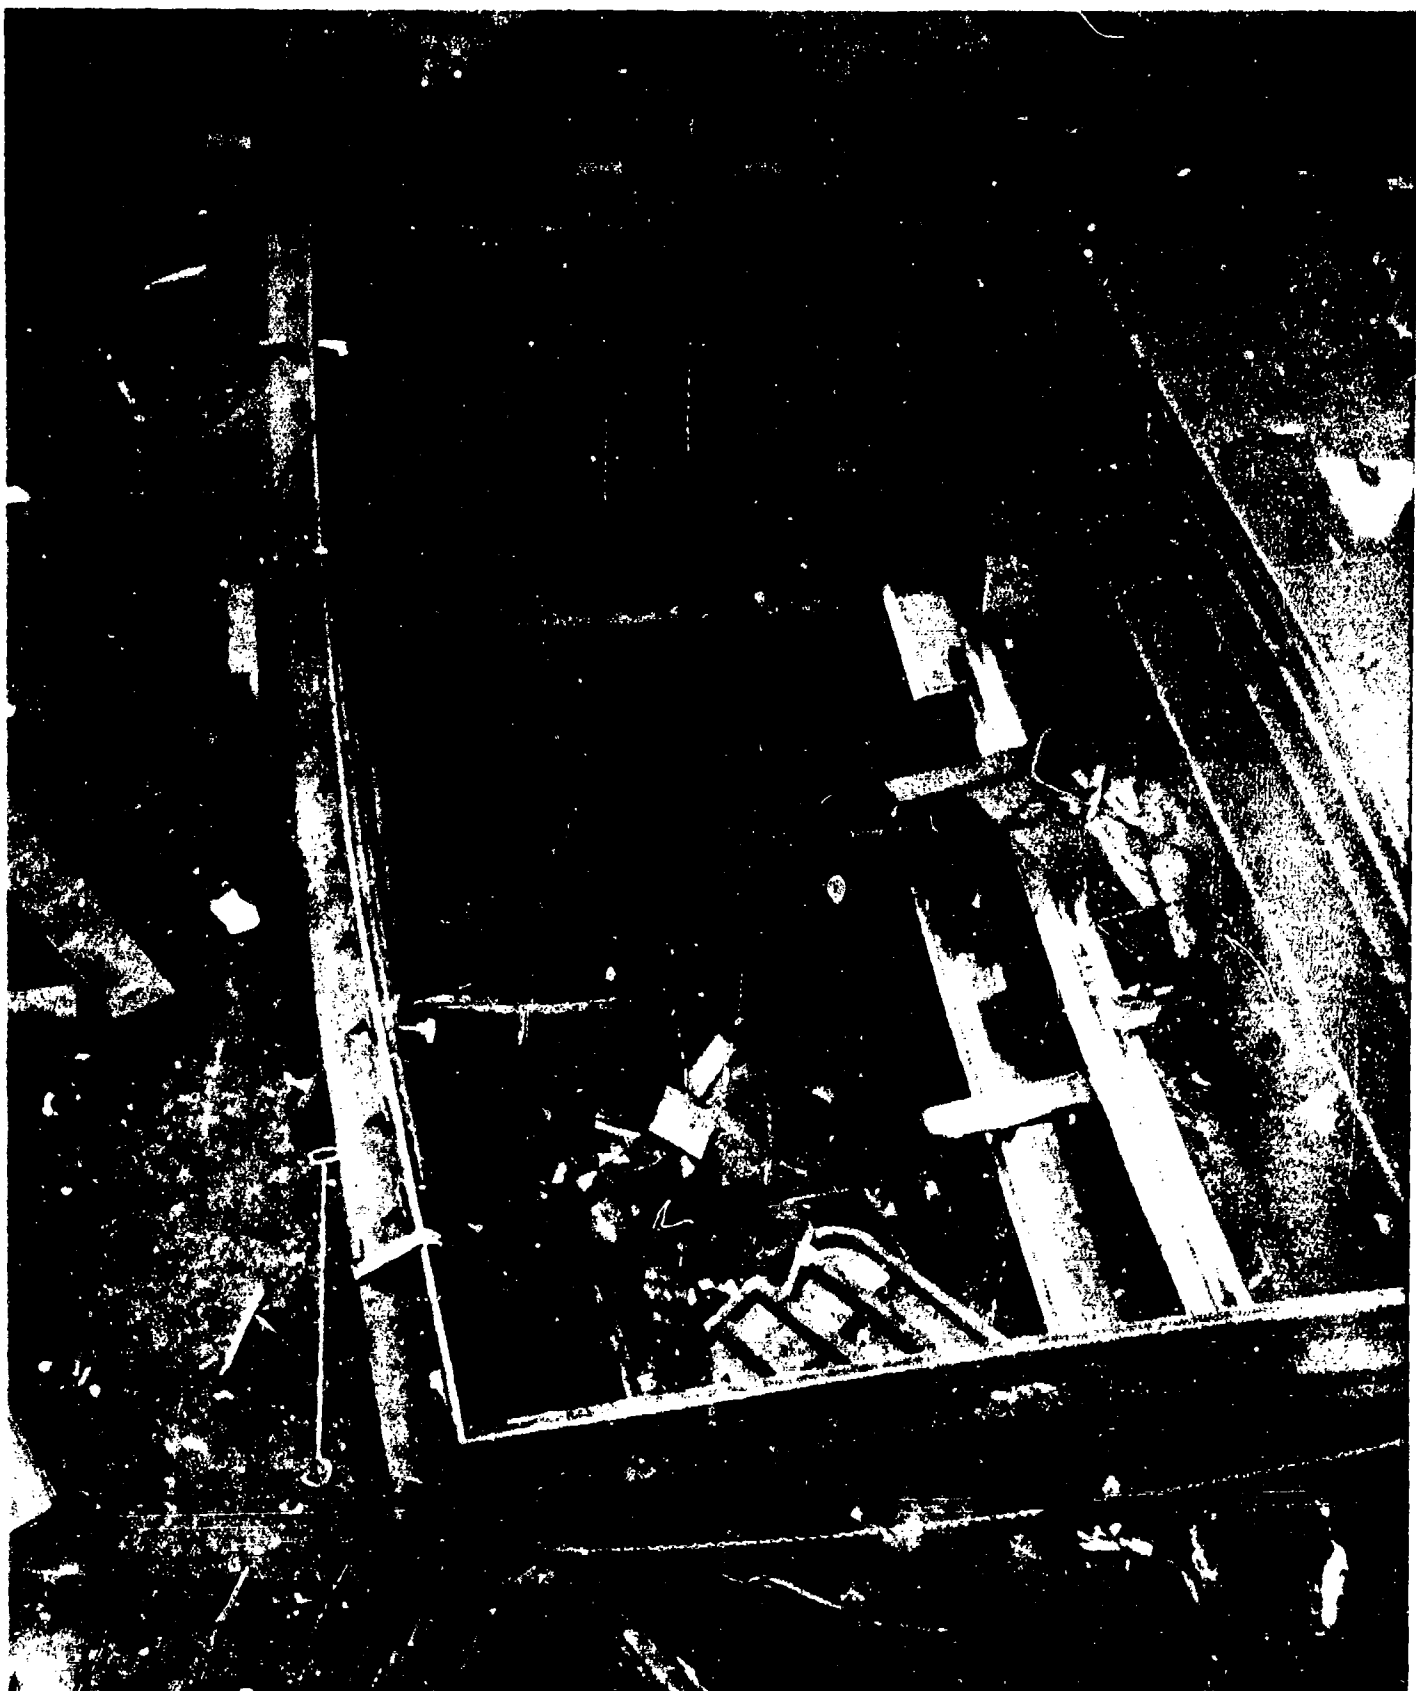
AA-CR-98-1961-5. Looking forward and down into forward cargo hold from signal bridge.

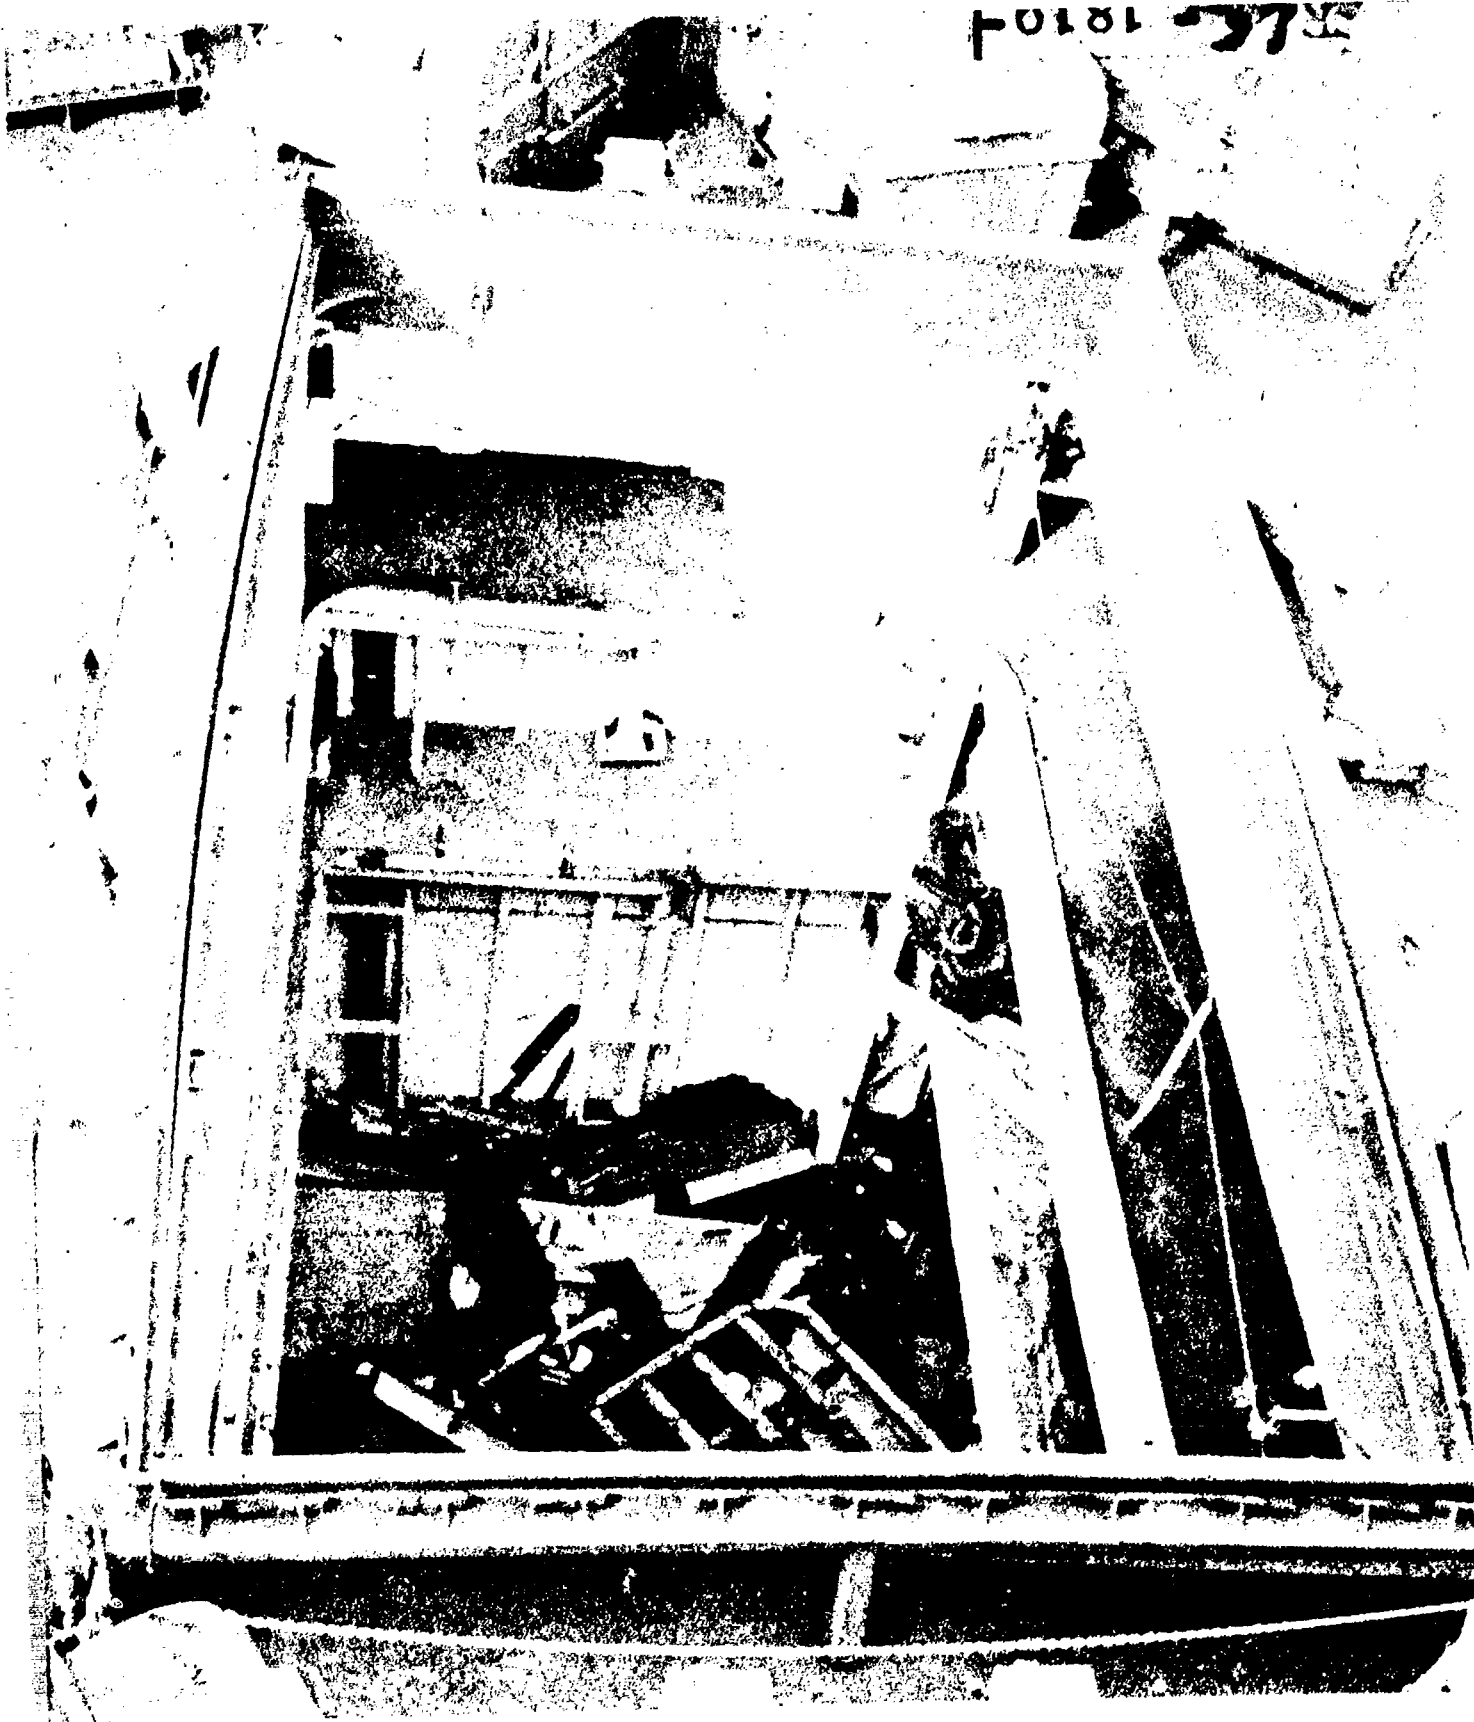
AA-CR-65-1819-4. Looking forward and down into forward cargo hold.
Note deflection outboard of upper deck coamings.

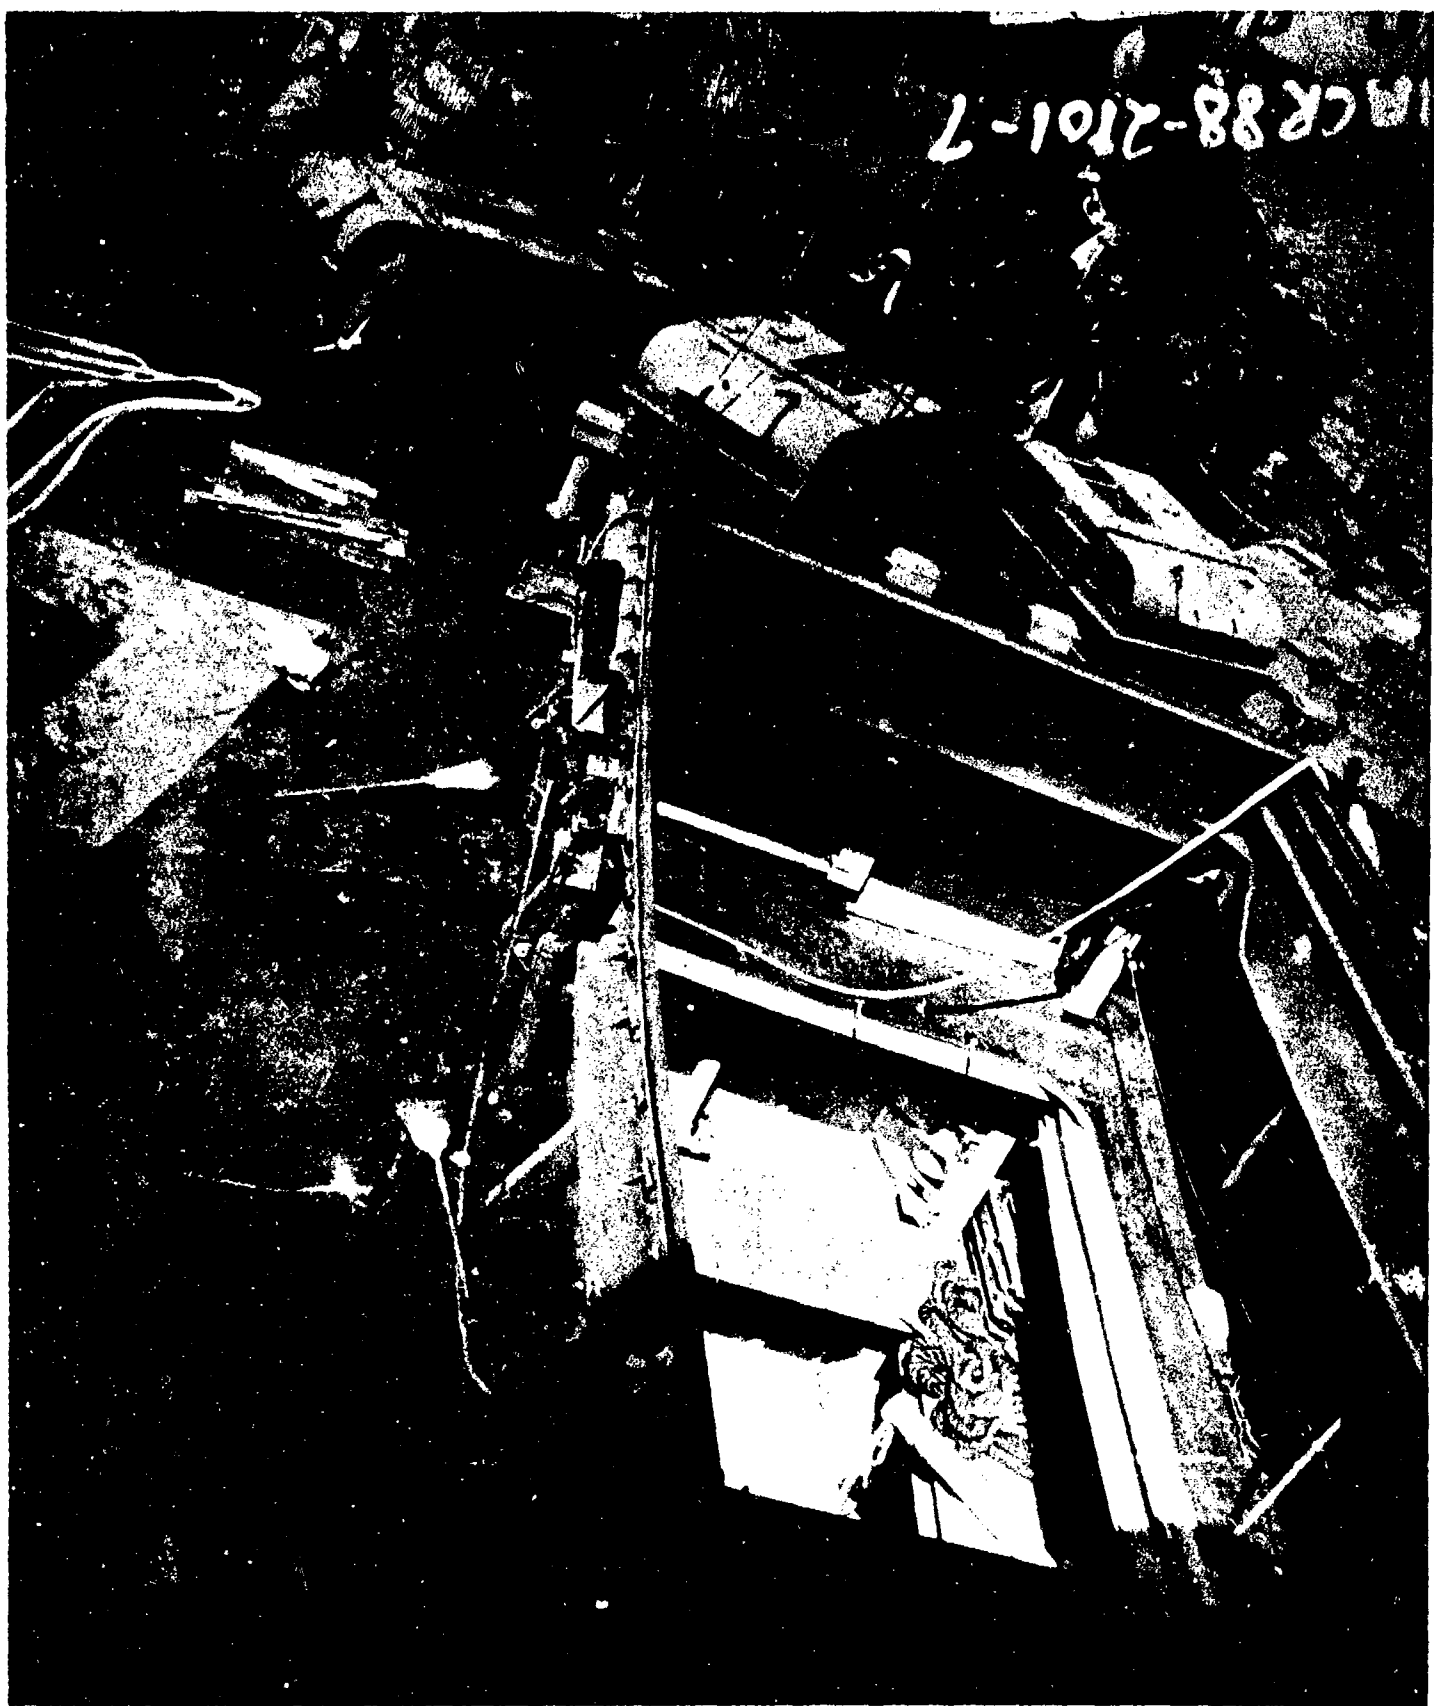
AA-CR-88-2101-7. Looking forward to starboard, and down into forward cargo hold from bridge structure.

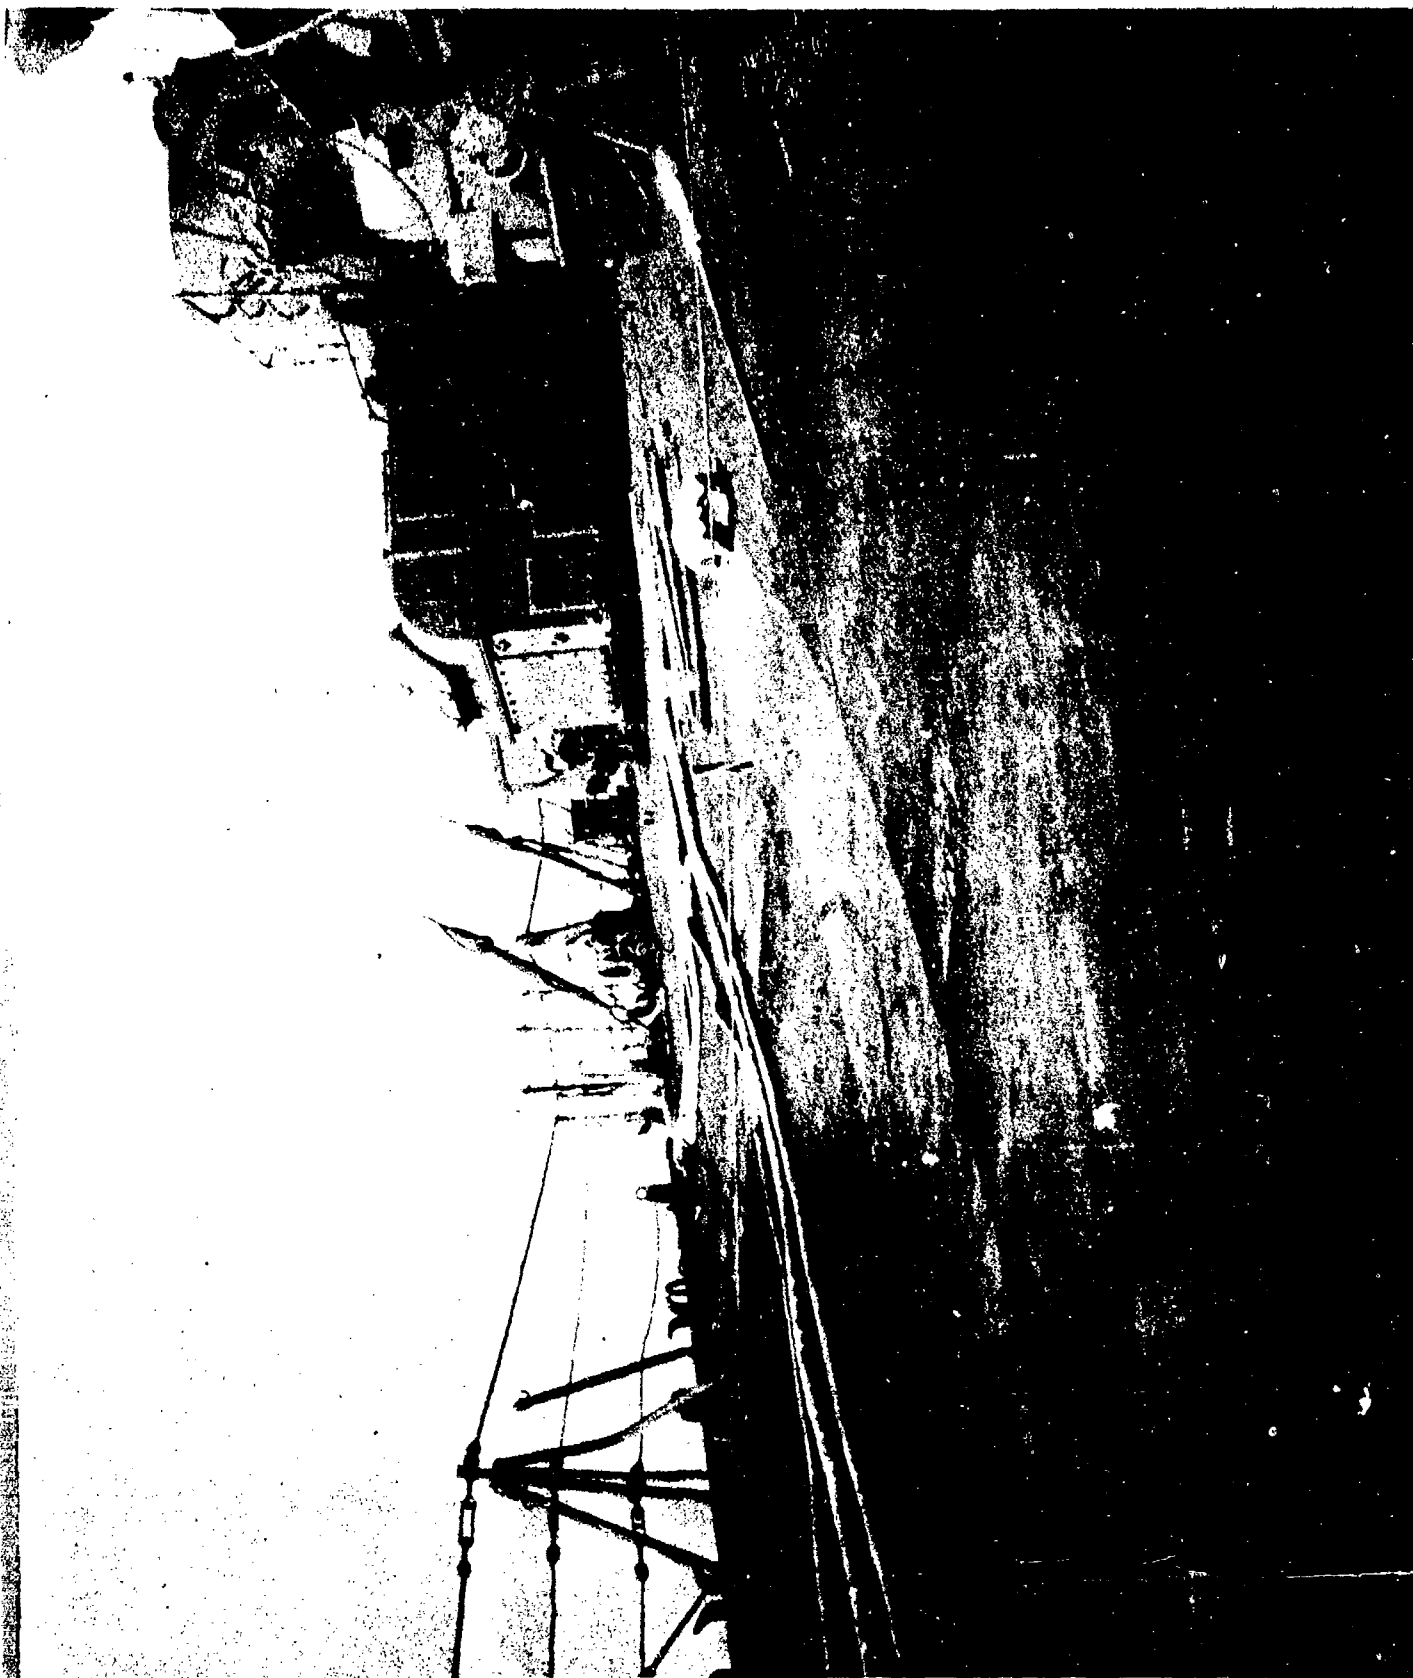
AA-CR-88-2101-9. Looking forward on upper deck, port, showing deck dishing in way of forward cargo hatch.

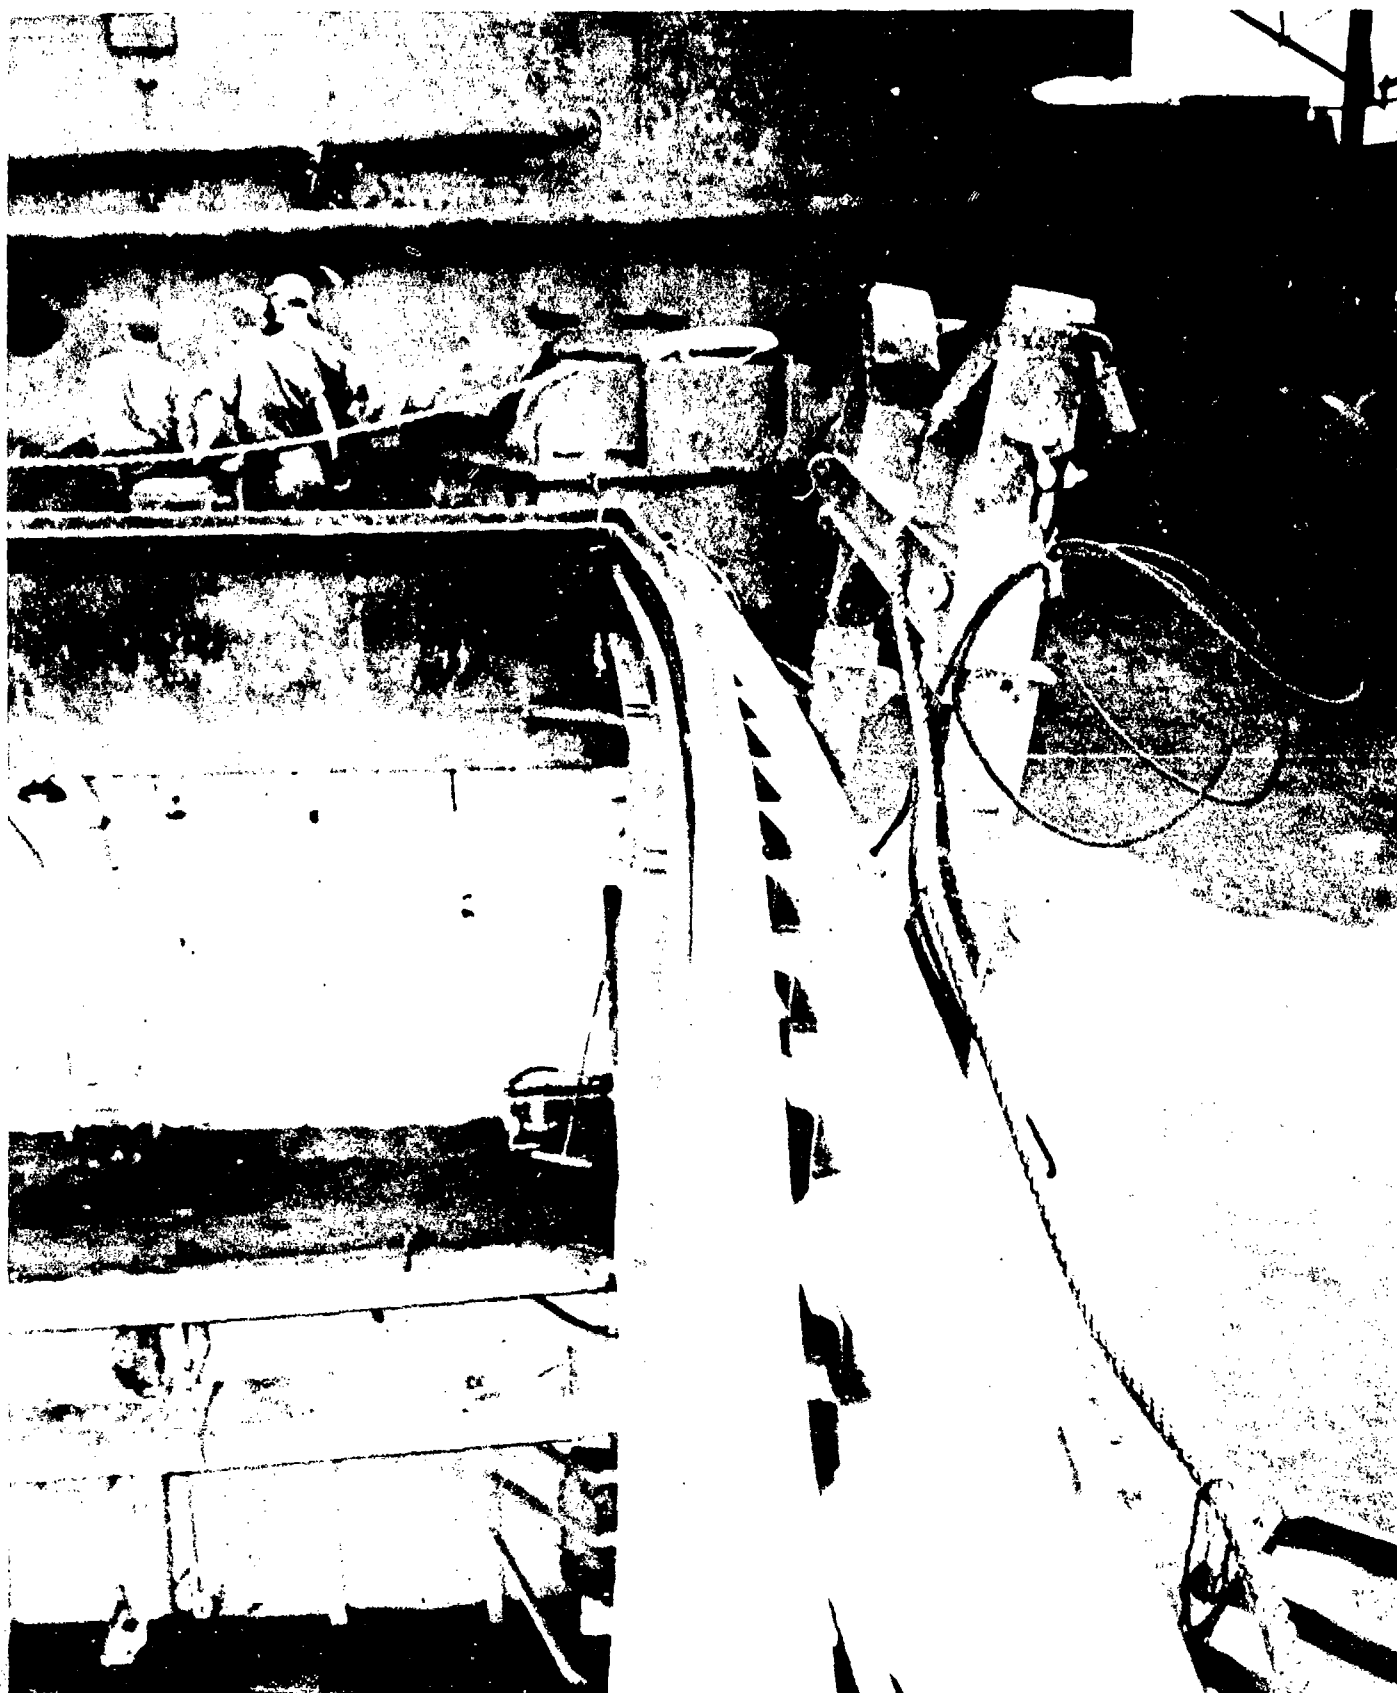
AA-CR-65-1817-9. Looking aft on upper deck, port, showing deflected coaming at port side of forward cargo hatch.
